Colton-Uniontown Trail Vision Framework

DRAFT

January 2023

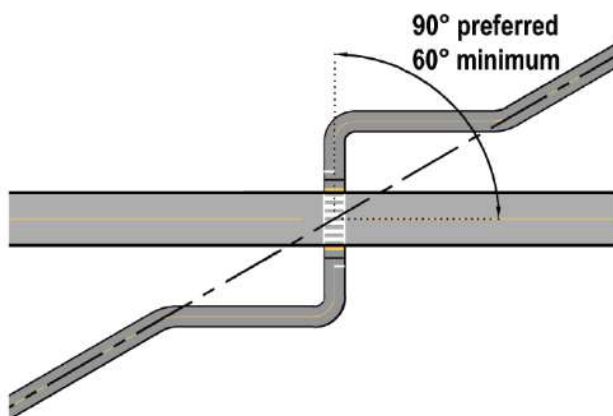
Figure 1: Shared Use Path Crossing Realignment

- » **Intersection Geometry.** The geometry of the intersection and crossing should be optimized to be as close to 90 degrees as practicable to minimize the exposure of crossing users and maximize sight lines (see Figure 1). The intersection and approaches should be on relatively flat grades, and should be visible to users of both facilities.

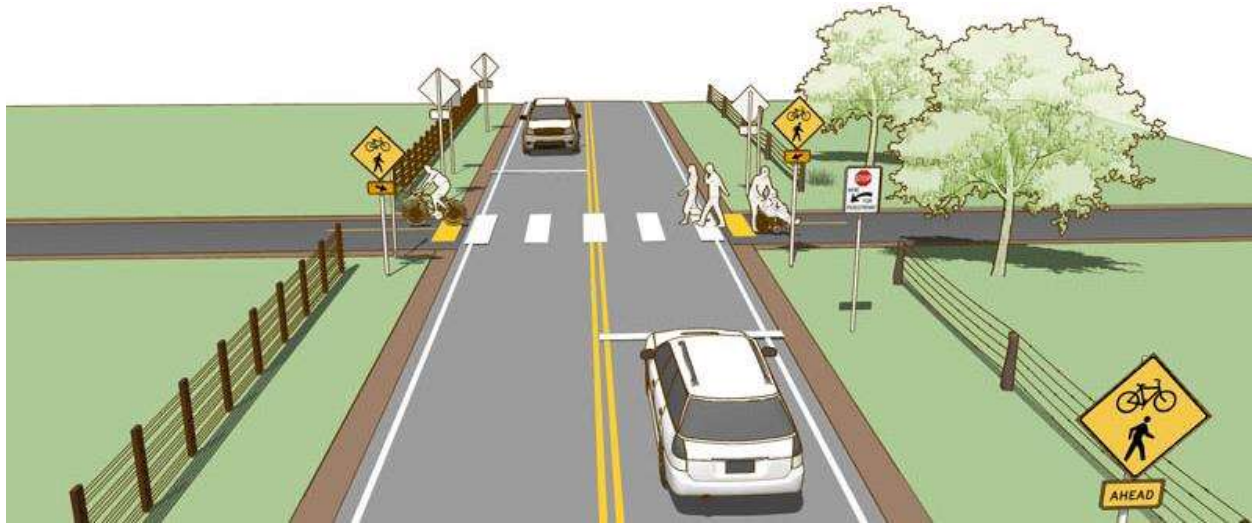
- » **Markings and Signage.** Road crossings should include high visibility marked crosswalks, accompanied by signage, to increase driver awareness of potential trail users and clearly delineate yielding responsibilities. Approaching road crossings, signage should alert trail users about crossing vehicular traffic. See the MUTCD for standard signage and pavement markings. Figure 2 provides an example of crosswalk markings and sign crossing treatments used where shared use path users stop or yield to traffic on the intersecting roadway.

*Figure 2: Marked Crosswalk and Signage Where Shared Use Path Stops or Yields to Intersecting Roadway (i.e. US-195)
(Source: FHWA Small Town and Rural Multimodal Networks Guide)*

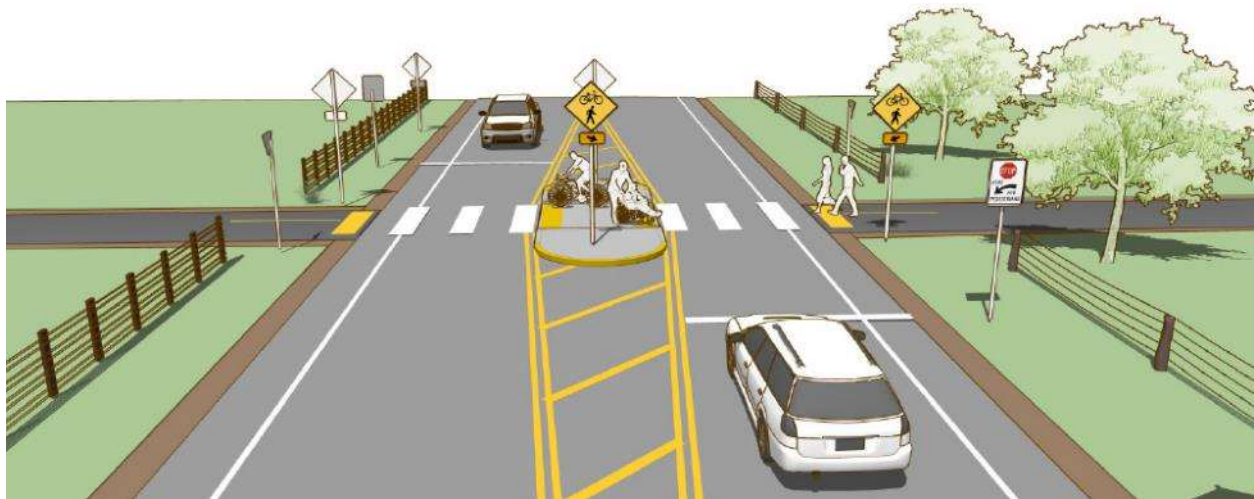
- » **Refuge Islands.** If the final trail alignment includes highway crossings on US-195, median refuge islands should be considered (Figure 3). Refuge islands are a proven safety countermeasure associated with significantly lower pedestrian crash rates at multilane crossings, particularly on roadways with higher traffic volumes and/or speeds. Refuge islands reduce crossing exposure and allow a trail user to perform a two-stage crossing of the highway. The cut through of the raised refuge island(s) should be 10 ft wide to match the trail width. The minimum length of the storage area, measured in the direction of pedestrian/bike travel, must be at least 6 ft.

Figure 3: Raised Refuge Median (Source: FHWA Small Town and Rural Multimodal Networks Guide)

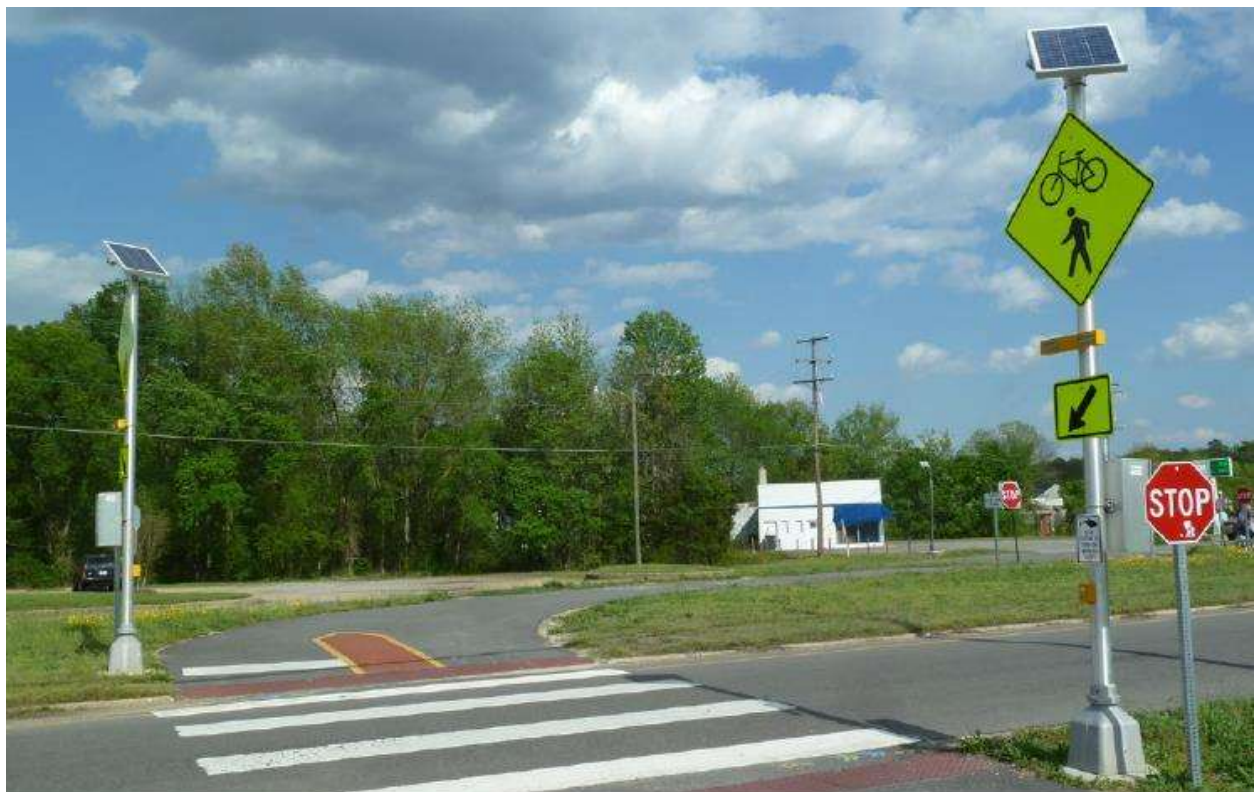
- » **Flashing Beacons.** Based on the speed limit (up to 60 mph) and annual average daily traffic on US-195 (5,612 AADT in 2022), Rectangular Rapid Flashing Beacons (RRFBs) may also be appropriate where the trail crosses the highway. These are user-actuated beacons that supplement warning signs at uncontrolled crossings. Research has shown that RRFBs can achieve motorist yielding rates between 80 and 100 percent both during the day and during periods of darkness. When used at locations where both pedestrians and bicyclists are crossing, a W11-15 sign should be used (see Figure 4).

Figure 4: Rectangular Rapid Flashing Beacons at a Trail Crossing

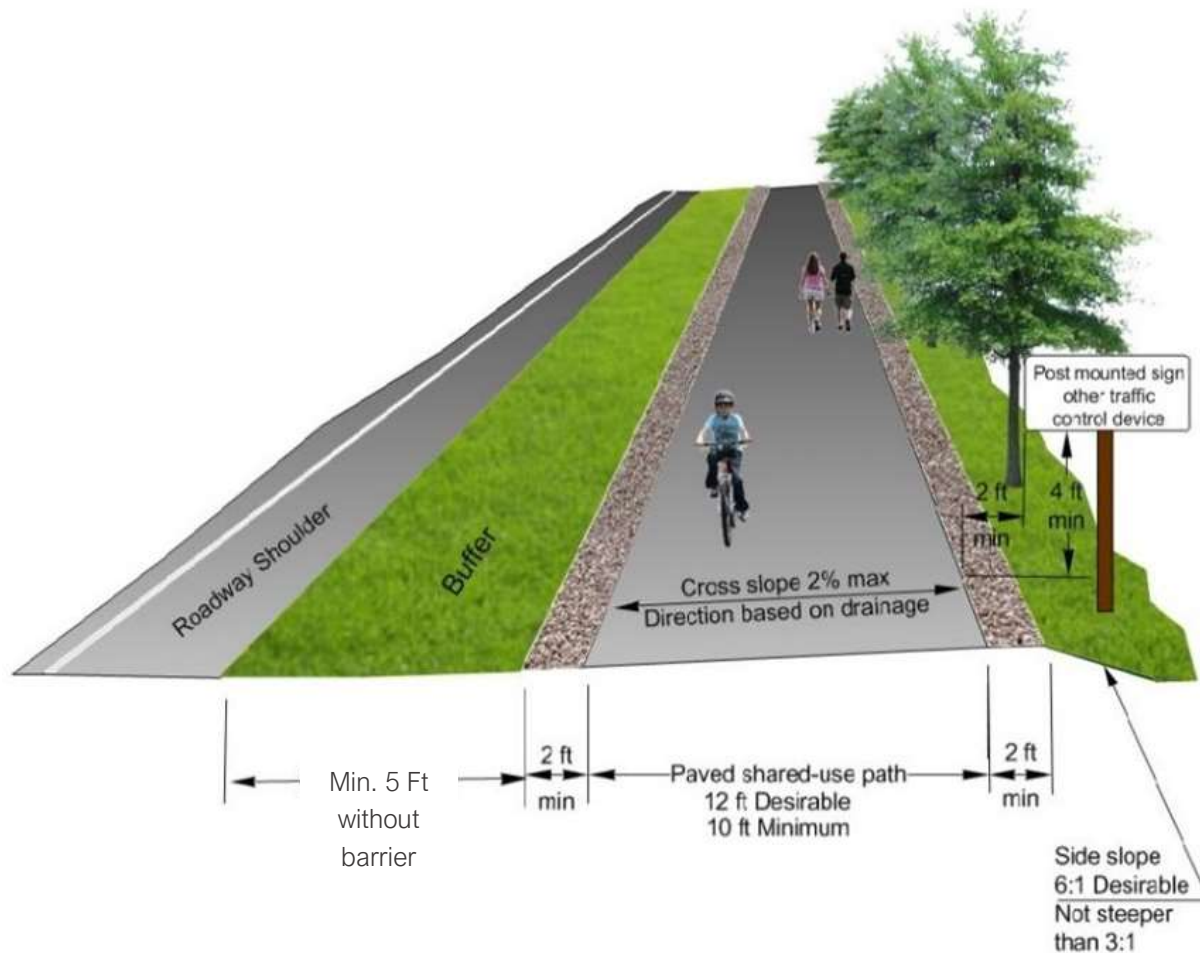
- » **Roadway Buffer.** For roadways with speeds greater than 35 mph, WSDOT requires a separation greater than 5 ft between the roadway and the trail (see Figure 5). If separation greater than 5 feet cannot be obtained, provide barrier separation in accordance with Figure 6.

Figure 5: Two-Way Shared-Use Path Adjacent to Roadway (> 35mph) (Source: WSDOT Design Manual Exhibit 1515-5)

- » **Width.** Paths should be at least 10 feet wide, with a preferred width of 12 feet, to support truck wheels at the edges (see Figure 5 on p. 14). It should include two-foot gravel shoulders on either side and possibly and adjacent soft surface trail for joggers and equestrians. Larger maintenance vehicles can cause significant edge damage if wheels ride at the edges. Narrow trails with high use tend to widen on their own, causing negative impacts to the surrounding vegetation and soils.

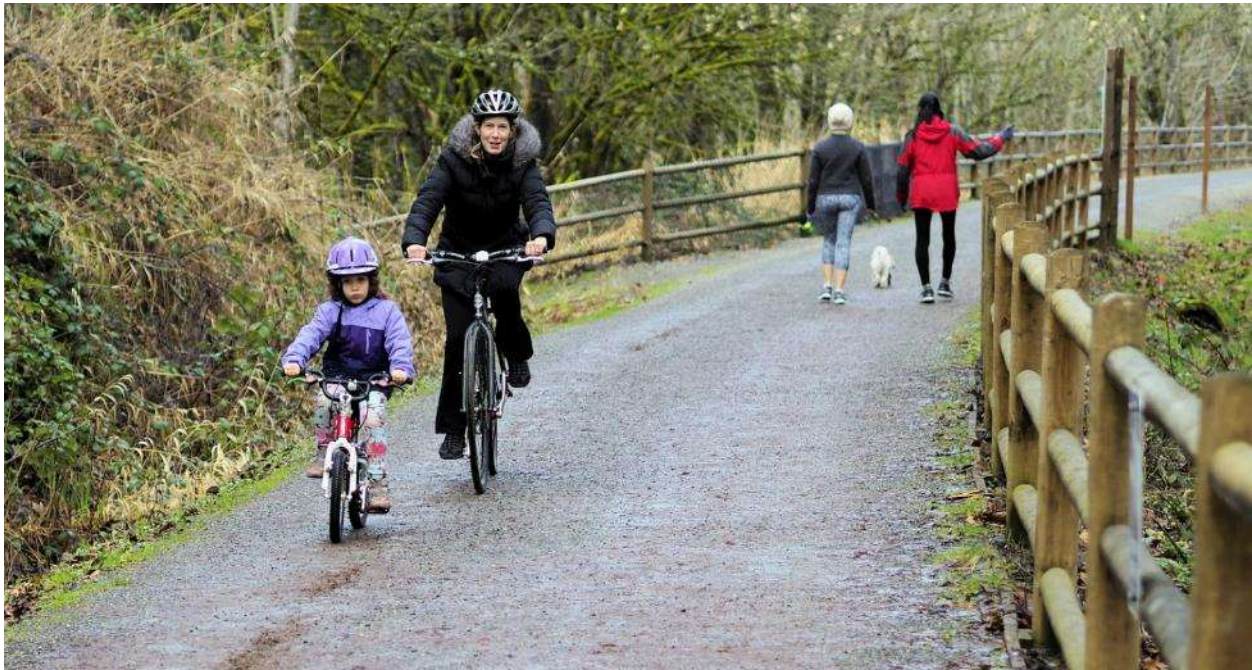
- » **Fencing.** Where the path is adjacent to a steep downward slope, and the adjacent shoulder is less than 5 ft in width, a physical barrier, such as fencing or a pedestrian rail, should be included to mitigate potential crash risks. Barriers, railings or fences adjacent to bikeways should be a minimum of 42 in. high where bicyclists are operating in close proximity. Where a bicyclist's handlebar may come into contact with a railing, a smooth, wide rub-rail may be installed at a height of between 36 in. and 44 in. to reduce the likelihood that a bicyclist's handlebar will be caught by the railing. However, on a shared use path with a running grade of 5 percent or greater pedestrian accessibility guidelines may require that a handrail be installed at or near this same height. In these cases, designer judgement should be used to ensure that any rub-rail that is installed does not interfere with the use of the accessible handrail. This applies to the following slope conditions:

- Slopes 1V:1H or steeper, with a drop of 1 ft. or greater

Figure 7: Trail adjacent to a downward slope with fencing (Kirkland, WA)

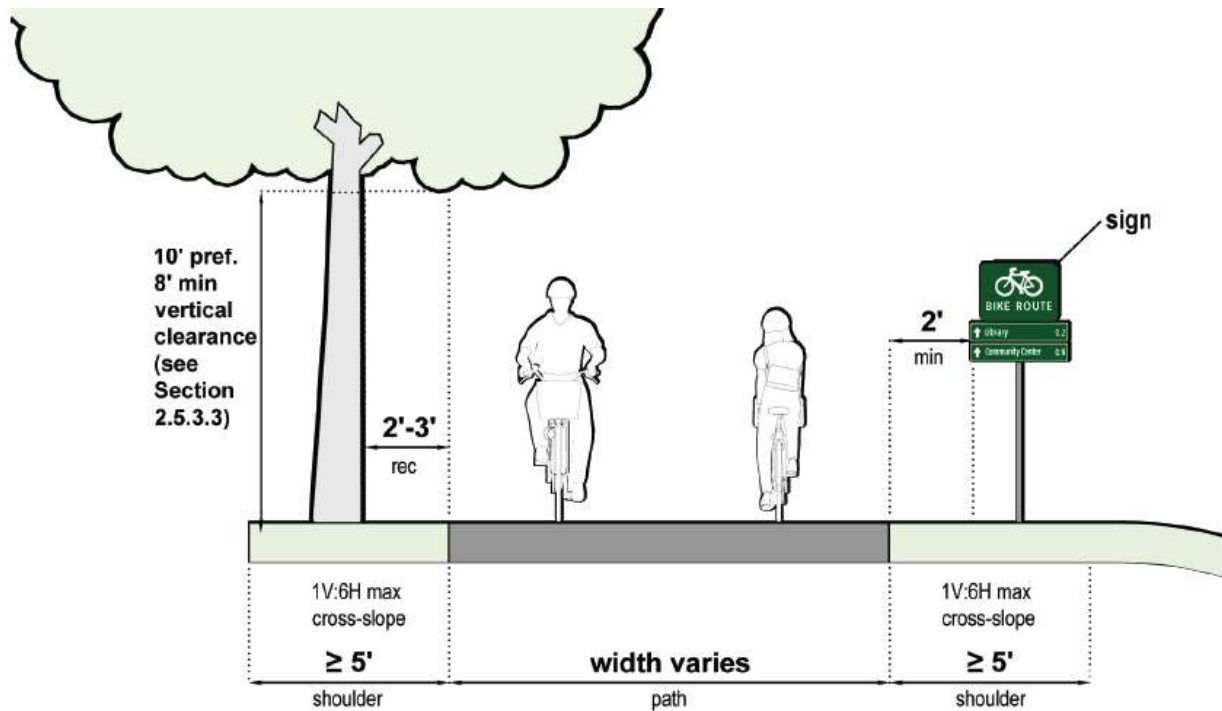
- » **Clearances and Shoulders.** Shared use paths should not have any fixed objects located within the clear width of the path because fixed objects present crash hazards to all users and limit the operational space. A graded shoulder with a maximum cross-slope of 1V:6H should be provided on both sides of all shared use paths. The shoulder is recommended to be a width of 5 ft. In constrained conditions—such as locations where the trail needs to squeeze past an obstacle such as a utility pole—shoulders may be reduced for short distances to a practical minimum of 2 ft width. The shoulder should be maintained and recoverable in all weather conditions (see Figure 7 and the previous Figure 6) and be clear of all lateral obstructions such as trees, bushes, large rocks, bridge piers, abutments, and poles. Constrained conditions may also require all trail users to share the same surface, dropping the separated soft-surface trail for equestrians and joggers.

Figure 8: Shoulders and Shy Distance on Shared Use Paths

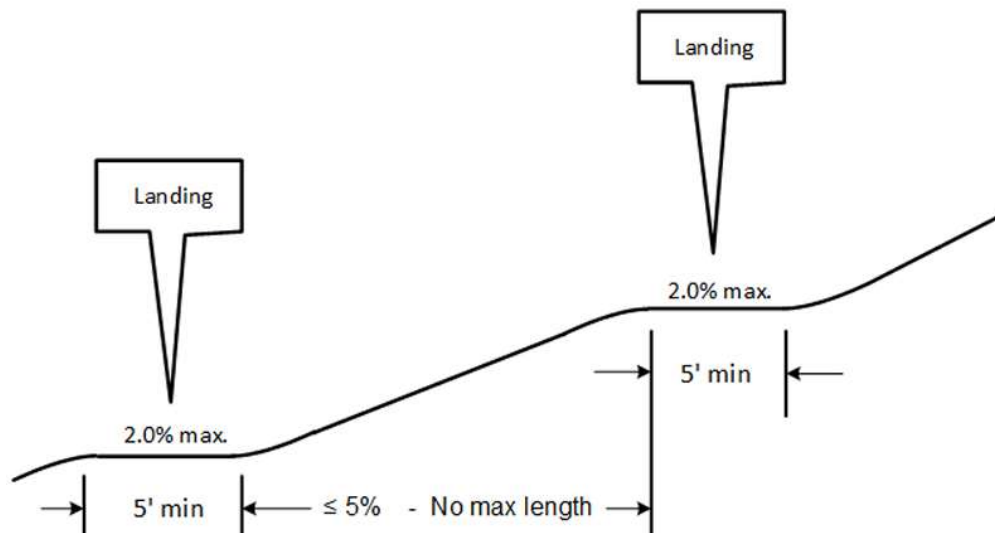
- » **Running Slopes.** Grades should be designed less than or equal to 5% to accommodate all user types, including pedestrians with disabilities. When the path is within the highway right of way, its running slope can match the general grade established for the adjacent roadway (WSDOT Design Manual 1515.02(3)(a)).
- » **Landings.** Landings are desirable to provide users a level place to periodically rest on extended grades, particularly those steeper than 5%, or when waiting to cross a roadway. They should be at least 5 ft long and should not exceed maximum running slopes and cross slopes of 2%.

Figure 9: Shared Use Path Landing Profile (Source: WSDOT Design Manual Exhibit 1515-9)

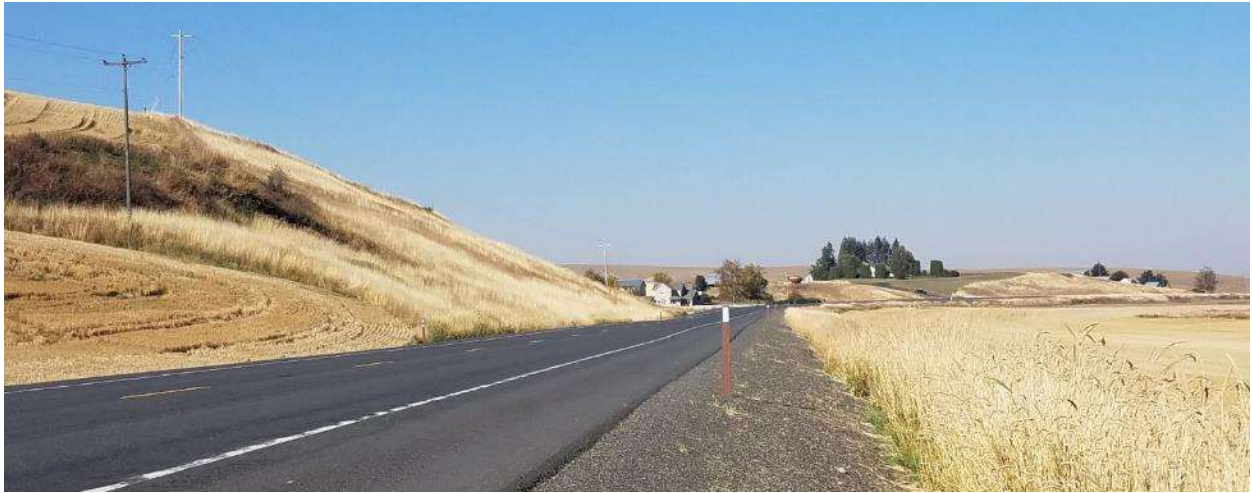
- » **Grading.** There are four locations along the west side of US-195 with grading challenges (see Figure 10). In particular, there is a steep drop-off on the west side of US-195 approaching Colton (see Figure 10). These locations could increase the cut and fill needed for a trail on those sections and may require retaining walls. They could also necessitate additional right-of-way acquisition. These locations may also require temporarily dropping the separated path for equestrians and joggers.

Figure 10: Steep slope along the west side of US-195 shortly after leaving Uniontown

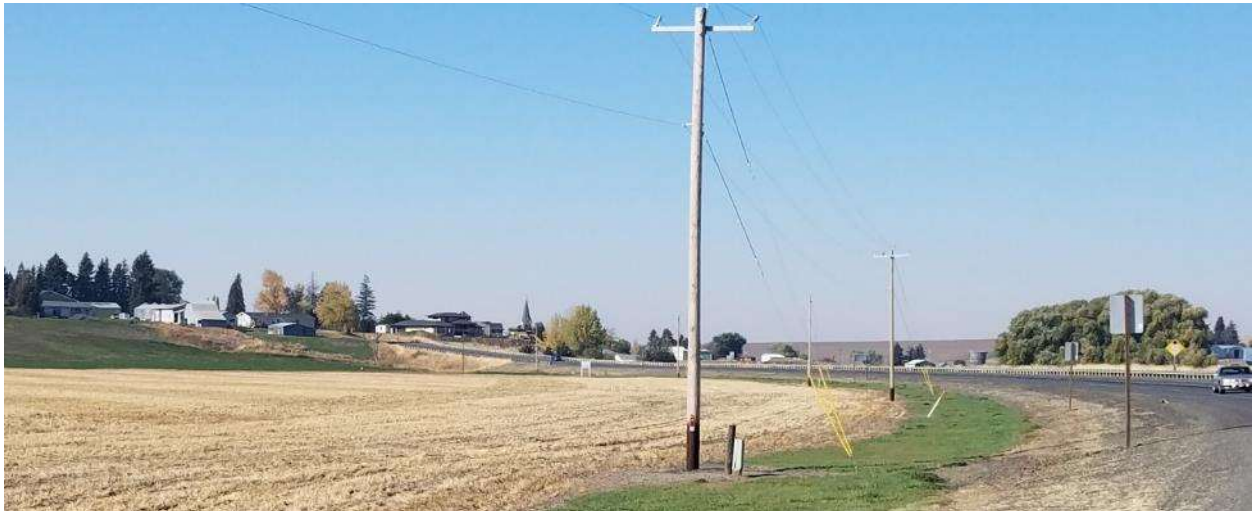
Figure 11: Steep slope along the west side of US-195 approaching Colton

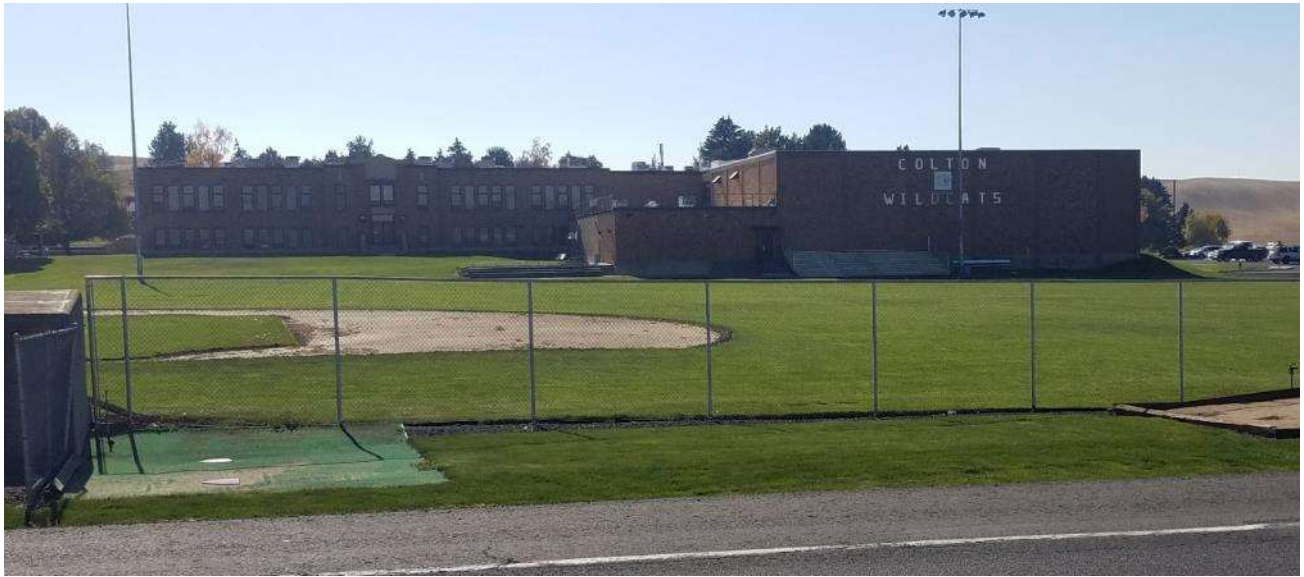
Figure 12: Colton School from US-195

- » **Telephone poles.** The utility poles and guy wires located along the west side of US-195 could potentially conflict with the proposed trail alignment, which may introduce additional costs and coordination needs.
- » **Colton High School.** Having the trail on the west side would enable an easier connection to Colton High School (see Figure 12), which would be a logical start/end point for the trail, without needing to cross US-195. Existing crosswalks in downtown Colton would make it relatively safe and easy to make the connection regardless of the trail alignment.

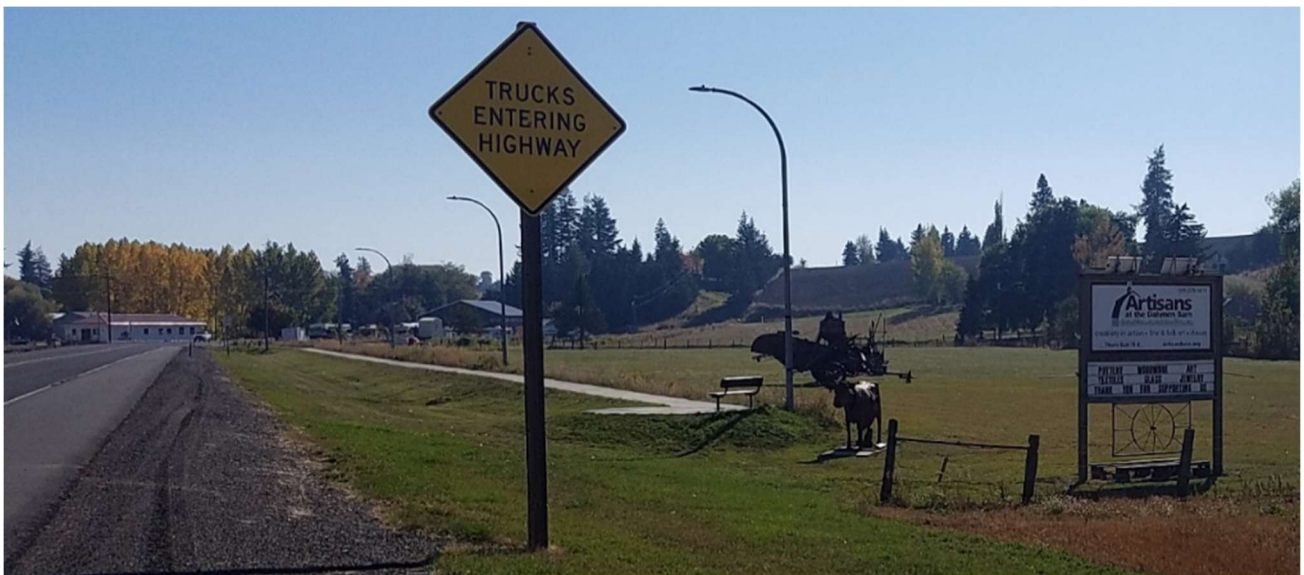
- » **More homes and driveways.** The west side of US-195 has approximately eight driveways/homes between Colton and Uniontown, compared to four on the east side. The higher number of driveways represents a challenge both in mitigating safety conflicts with trail users and turning vehicles and mitigating potential conflicts with adjacent landowners. The houses are also closer to the road, with the potential for greater privacy concerns.
- » **The Artisans at Dahmen Barn and Gone West RV Park.** Having the trail on the west side would better serve both the Dahmen Barn and the Gone West RV Park. In both cases, visitors are anticipated to include trail users.
- » **Connection to existing sidewalk.** Approaching Uniontown, the trail would connect directly to the existing, recently built sidewalk (see Figure 13).

Figure 13: End of existing sidewalk from Uniontown, next to the Dahmen Barn

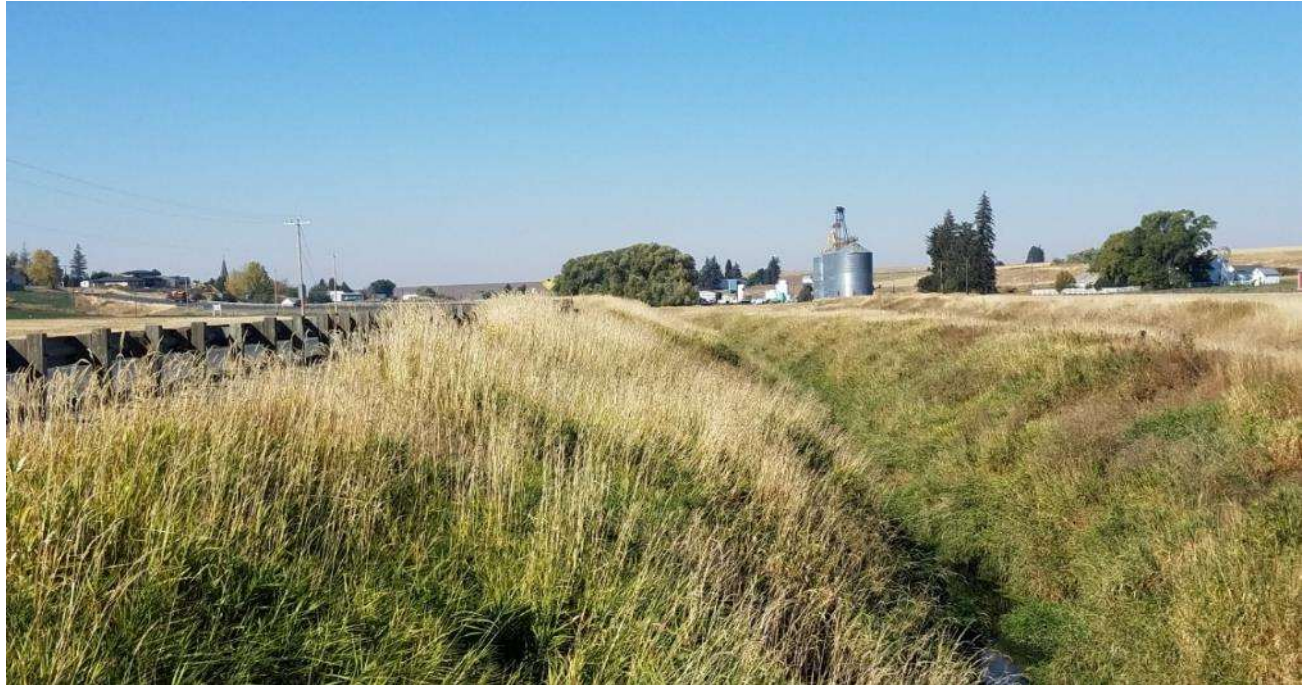
- » **Union Flat Creek.** Approaching Colton, the Union Flat Creek runs very close to US-195 (see Figure 14), leaving little room for a trail. Any additional construction along the east side of highway would probably impact the stream, which would trigger additional analysis and permitting, most likely including a [Hydraulic Project Approval \(HPA\)](#) from the Washington Department of Fish and Wildlife. Another option here is to cross the stream at roughly the same location where the railroad bridge used to be located and follow the Creek to Depot Road. This would also require addition permitting and the cost of a bridge.

Figure 14: Union Flat Creek along US-195, looking north approaching Colton
